MANUAL N° 814 - 2

# **BODYWORK**

## I - REPLACEMENT OF FRONT SUB-ASSEMBLY OF FRONT BODY UNIT

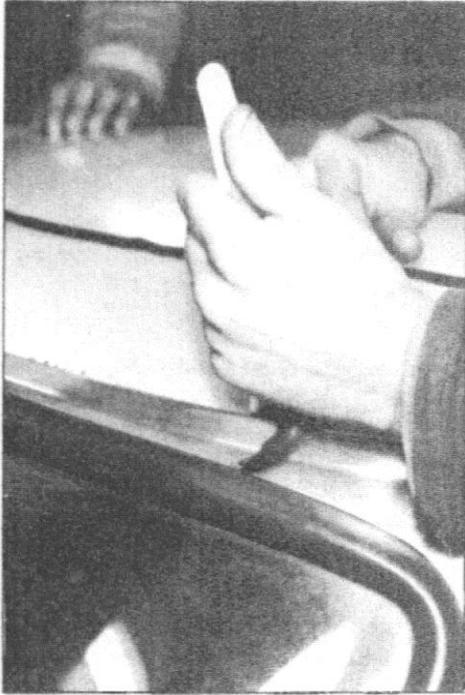
Position ribbons of front sealing compound into the guttering, packing it well down and taking care to ensure that the upper lip of the rubber is covered.

Smooth the sealer, using a cloth soaked in soapy water.
